INSTALLATION RESTORATION PROGRAM

SURVEILLANCE AND OVERSIGHT OF REMEDIAL ACTIONS AT SITE 2 AND SITE 4

FINAL COMPLETION REPORT

MICHIGAN AIR NATIONAL GUARD ALPENA COMBAT READINESS TRAINING CENTER

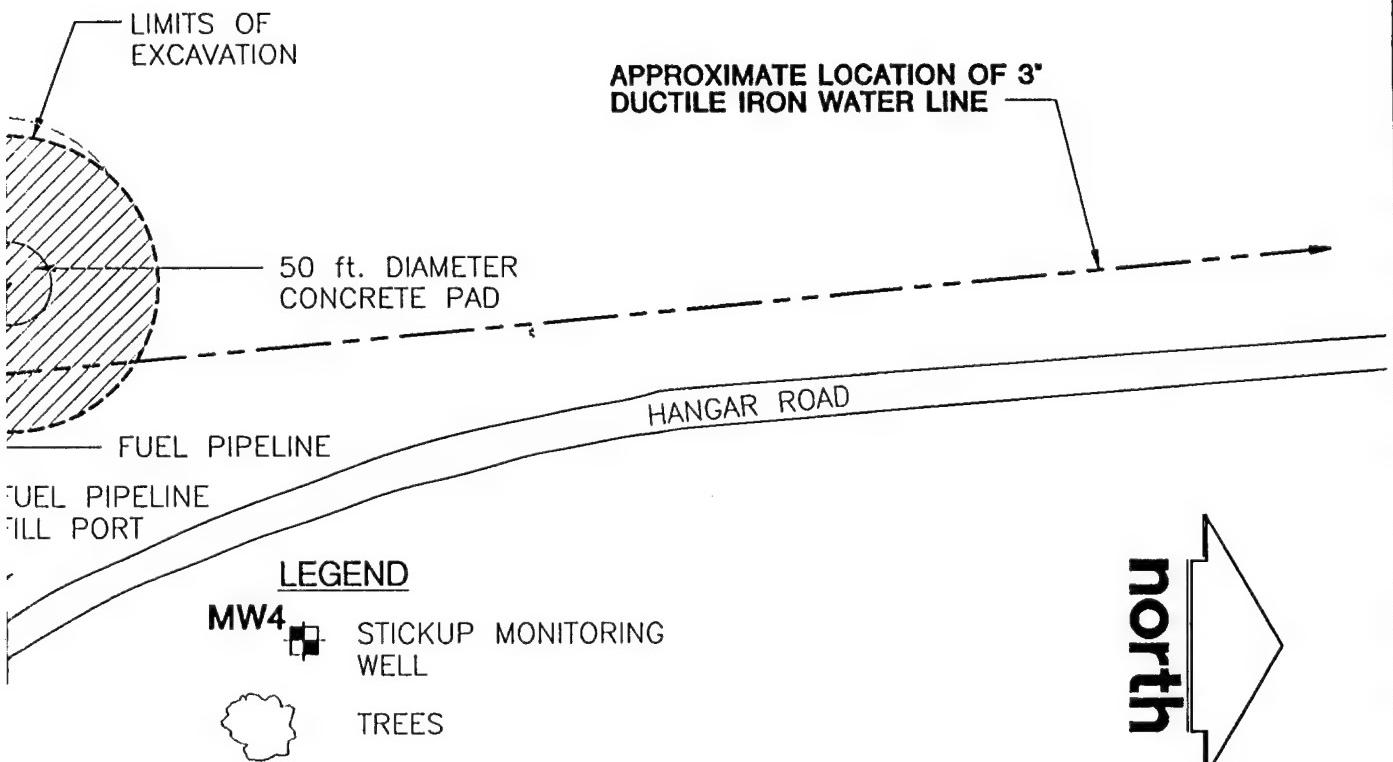
Drawing Number
8

3.2.3 Damaged Utilities. Excavation of contaminated soil at Site 4 resulted in damage to a three inch ductile iron water line and a 50-pair communications cable (Figure 9). The three inch water line was damaged while excavating soil southeast of the concrete pad. The location of the water line had not been marked. To complete excavation of soils in this area, it was necessary to shut off and disconnect a section of this line. Following excavation of the contaminated soil, base personnel replaced the disconnected and damaged sections of waterline. The 50-pair communications cable was damaged while excavating soil east of the fuel pipeline. The location of the communications cable had been marked at the beginning of the project; however, the markings were not discernible at the time of the damage. Unico contacted the communications company and the damage was repaired.

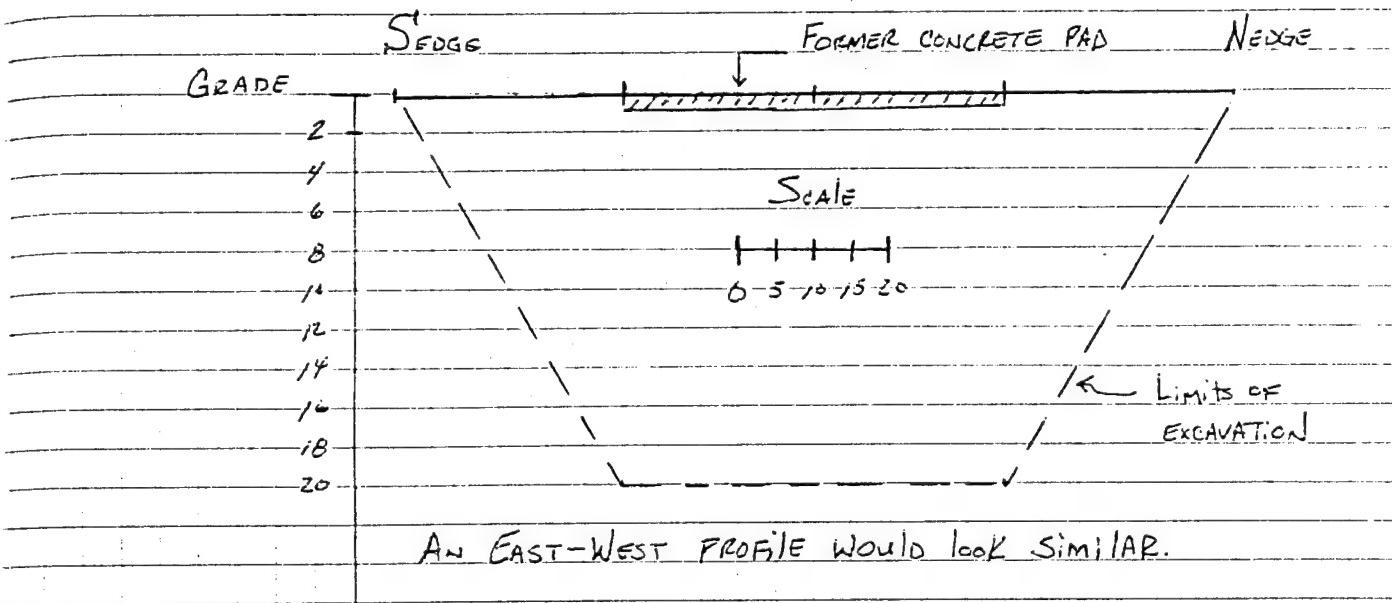
A SKETCH OF THE PROFILE OF
THE EXCAVATION IS AS FOLLOWS:

AN EAST-WEST PROFILE WOULD LOOK SIMILAR.

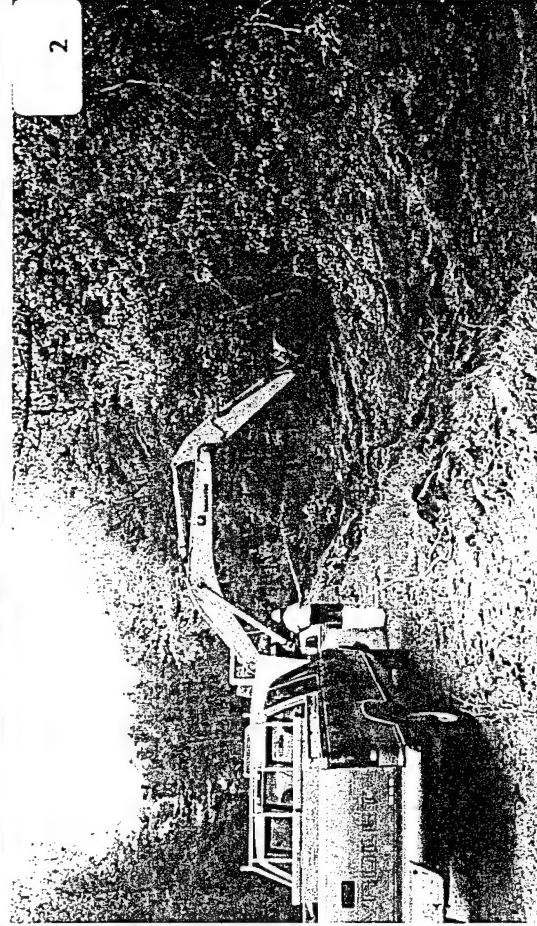
Photo Date: 6/22/95. Photo Direction: W.

Site 2. Mixing dry cement with impacted soil.

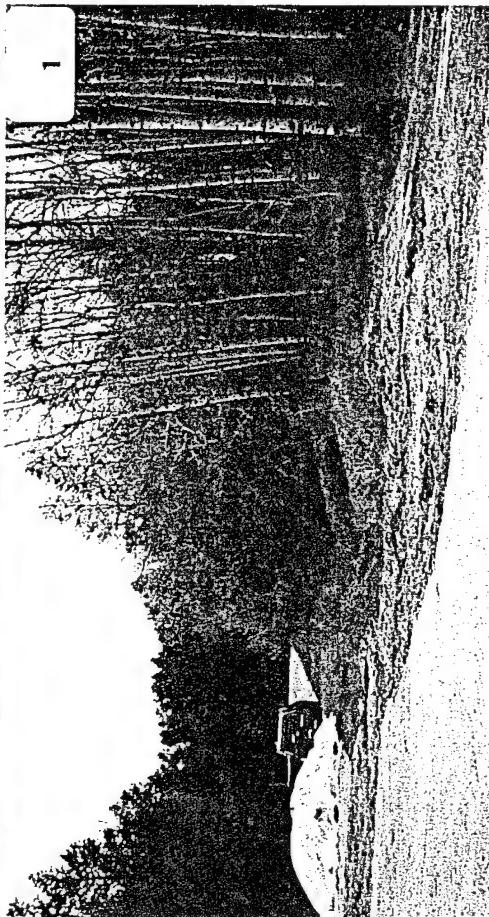
Photo Date: 6/22/95. Photo Direction: W.

Site 2. Drainage ditch prior to remediation activities.

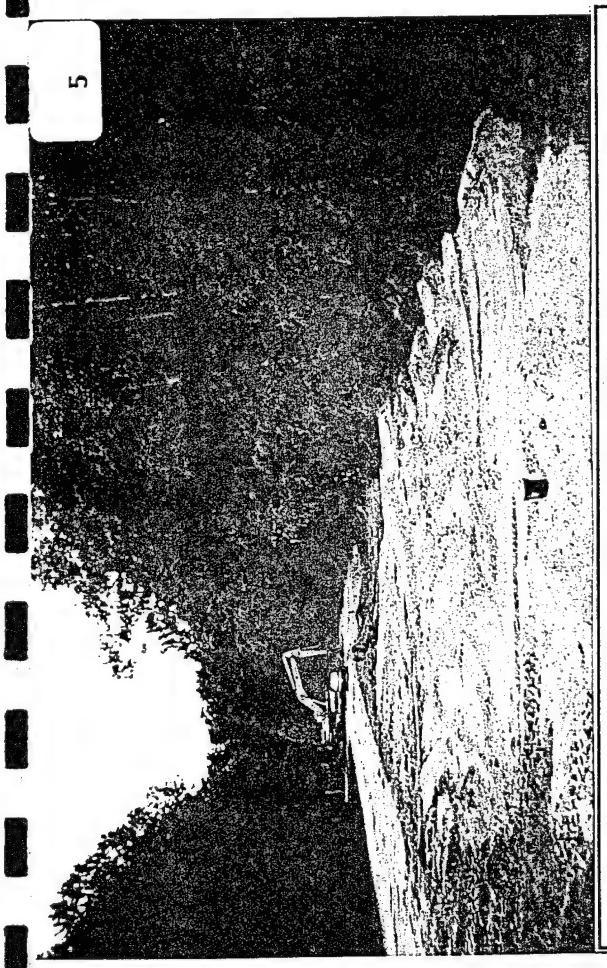
Site 2. Drainage ditch following completion of remediation activities. Photo Date: 8/14/95. Photo Direction: W.

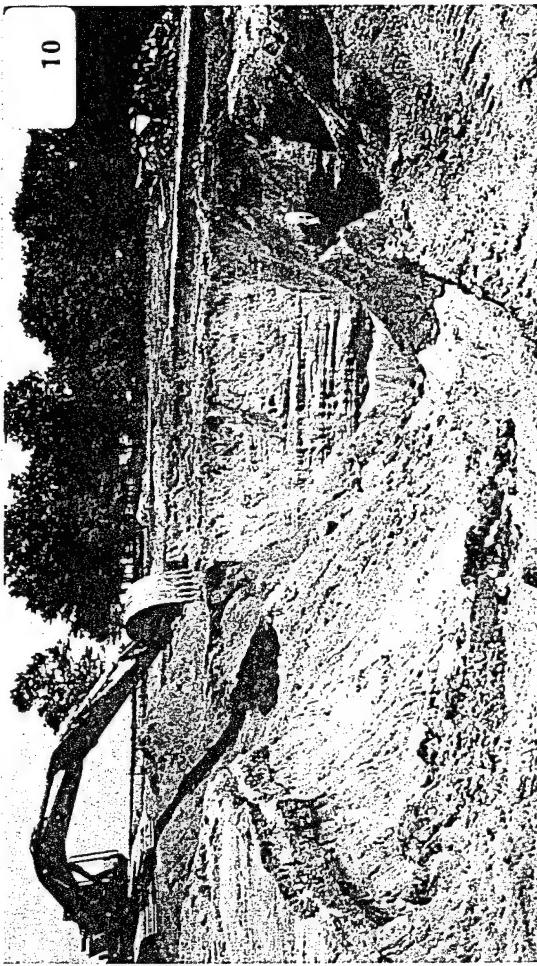
10

Site 4. Concrete pad at Fire Training Area prior to remediation activities. Photo Date: 5/24/95. Photo Direction: W.

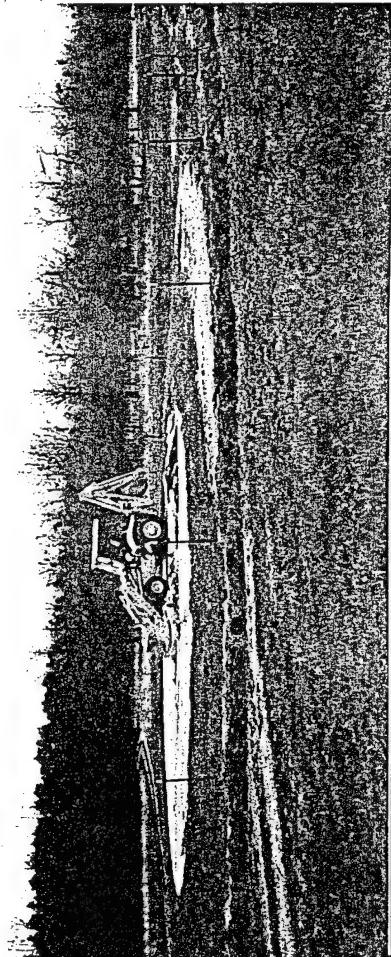
9

Site 4. Excavation in the area of the former concrete pad. Water table at approximately 20 to 25 ft below grade. Photo Date: 7/26/95. Photo Dir.: NW.

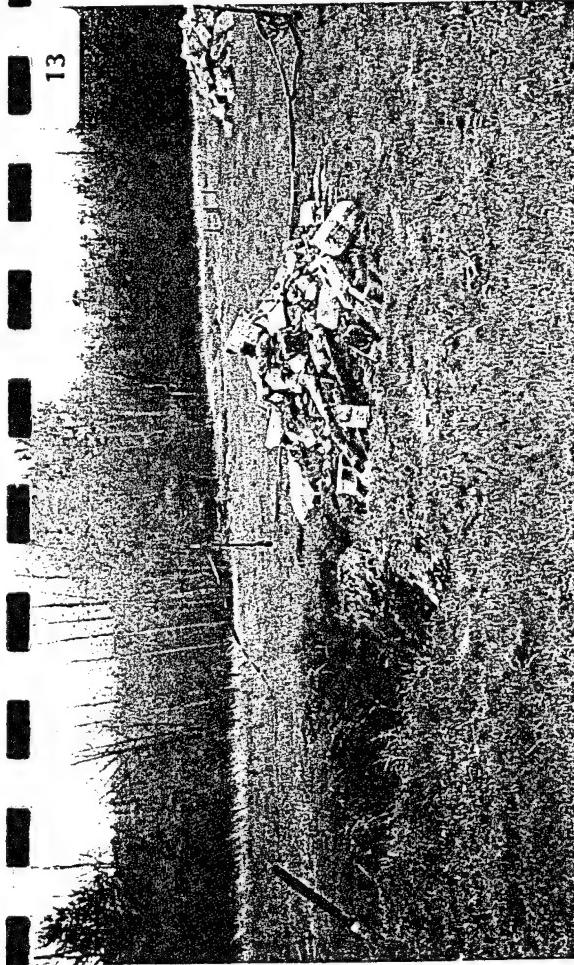
Site 4. Excavation of the block pit and fuel line (piping in foreground).
Photo Date: 6/22/95. Photo Direction: S.

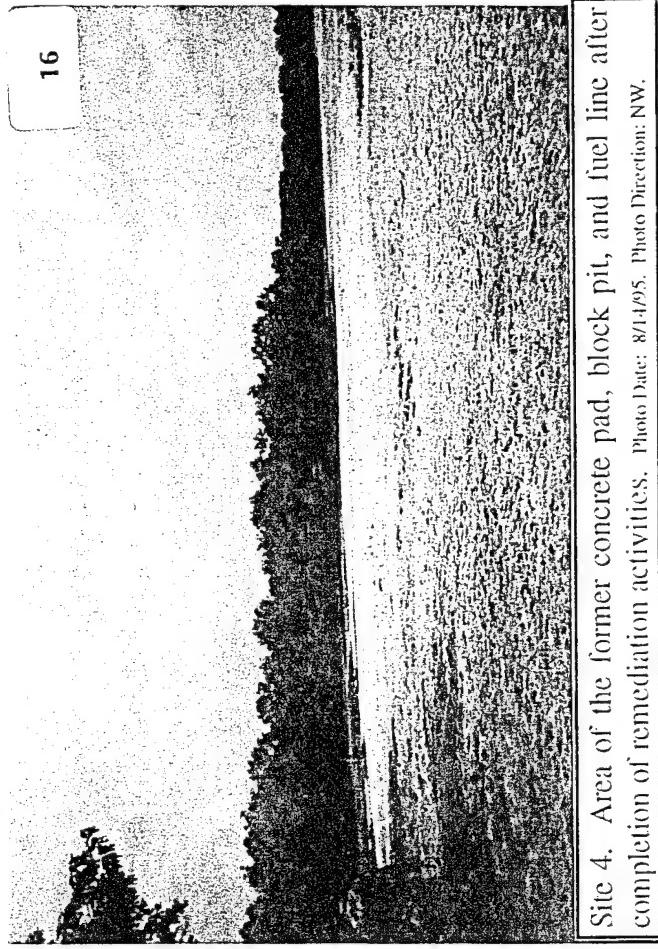
Site 4. Area of the former concrete pad, block pit, and fuel line after completion of remediation activities. Photo Date: 8/14/95. Photo Direction: NW.

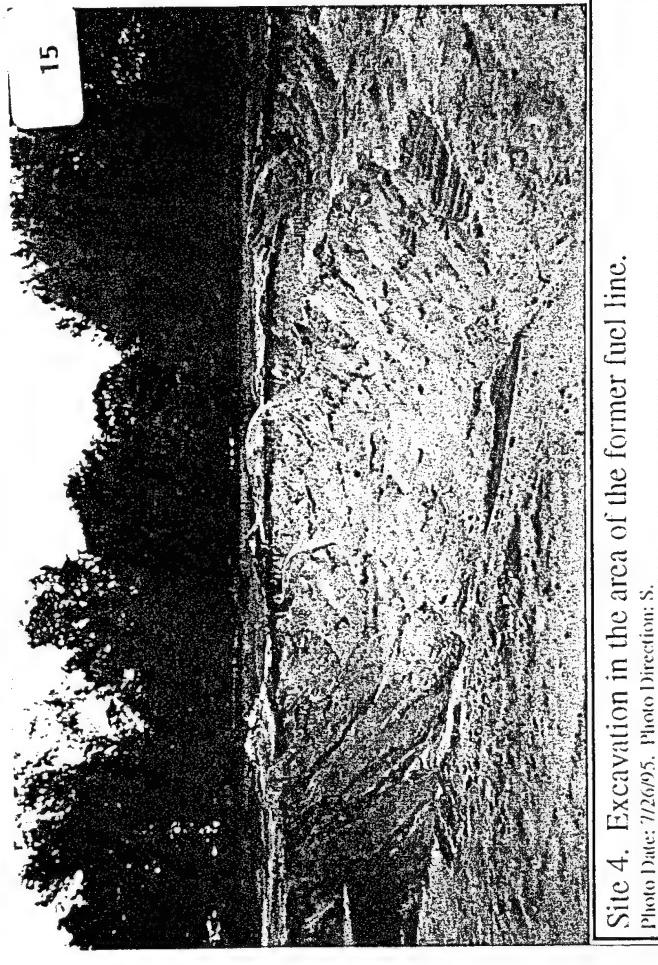
Site 4. Excavation in the area of the former fuel line.
Photo Date: 7/26/95. Photo Direction: S.

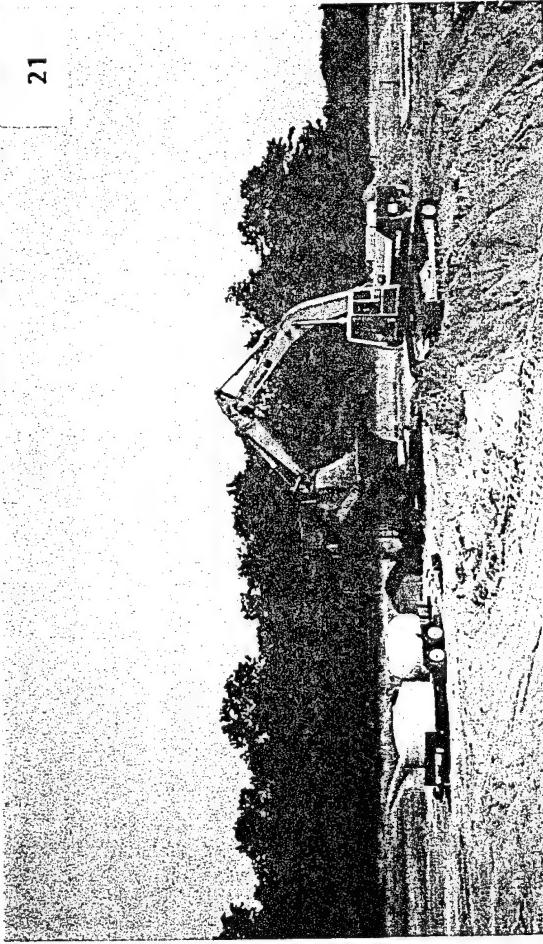
Site 4. Construction debris from the area of the gully and the former concrete pad awaiting disposal. Photo Date: 5/24/95. Photo Direction: E.

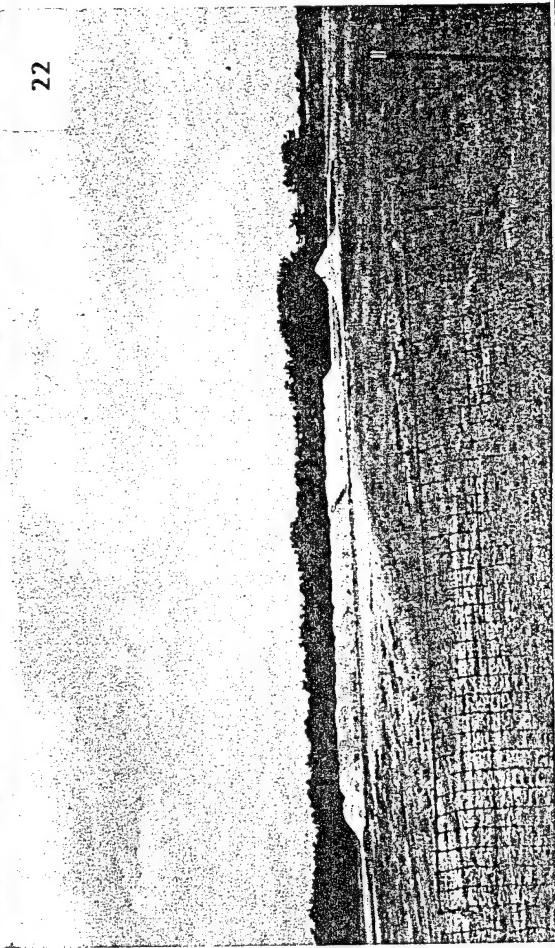
Site 4. Impacted soil being fed into the shredder. Impacted soil is inoculated with bacteria/nutrient solution. Photo Date: 6/22/95. Photo Direction: S.

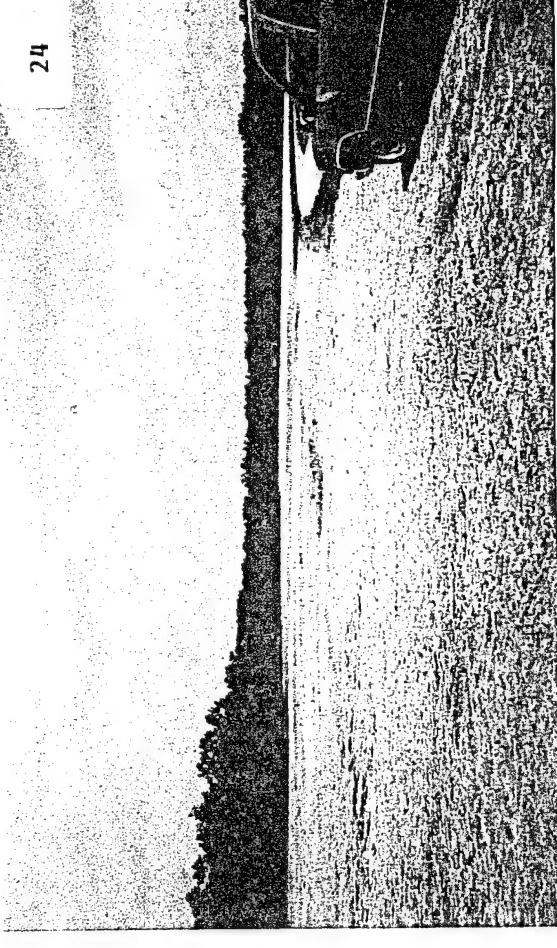
Site 4. Biocells located north of excavations. Typical biocell is 200ft x 50ft and holds 1,000 - 1,500 cyds. of soil. Photo Date: 7/6/95. Photo Direction: N.

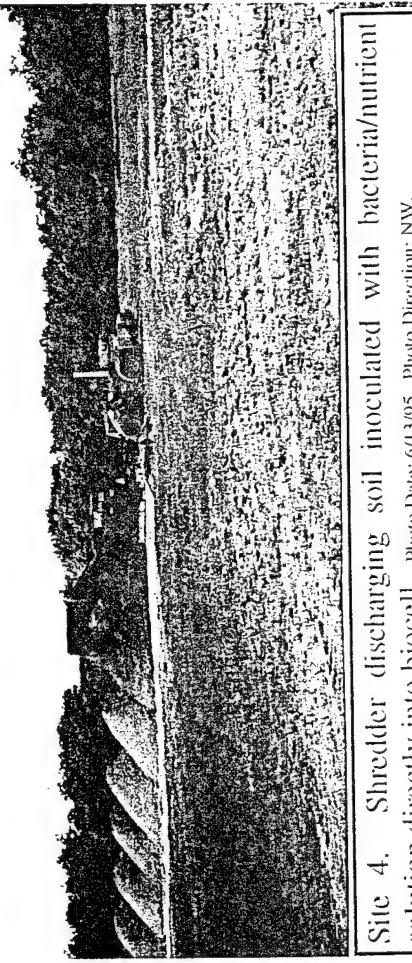
24

Site 4. Shredder discharging soil inoculated with bacteria/nutrient solution directly into biocell. Photo Date: 6/13/95. Photo Direction: NW.
